## HYDRAULIC TAPPET AND HYDRAULIC LASH ADJUSTER

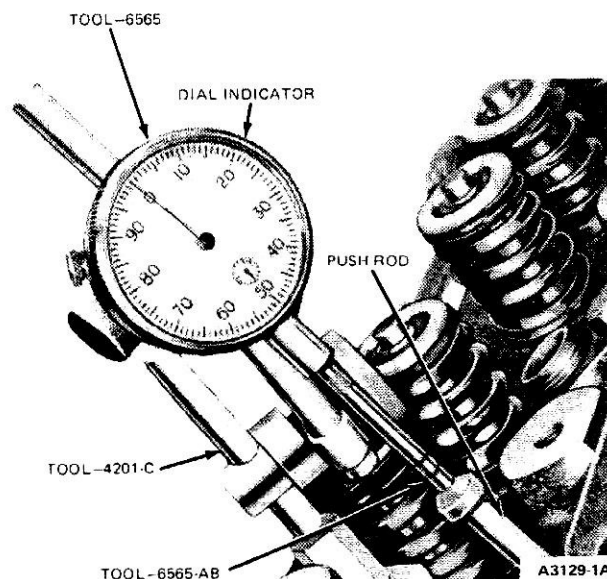
**FIG. 4 Testing Camshaft Lobe Lift—Rocker Shaft Mounted Rocker Arms**

3. Make sure the push rod is in the valve lifter socket. Install a dial indicator in such a manner as to have the ball socket adapter of the indicator on the end of the push rod and in the same plane as the push rod movement (Fig. 4 or 5).

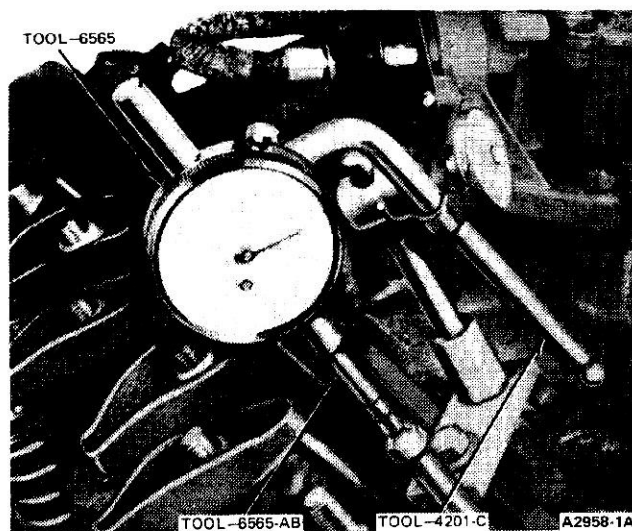
**FIG. 5 Testing Camshaft Lobe Lift—Stud Mounted Rocker Arms**

On the stud mounted rocker arms, remove the rocker arm stud nut, fulcrum seat, oil deflector and rocker arm. Use the adapter for ball-end push rods.

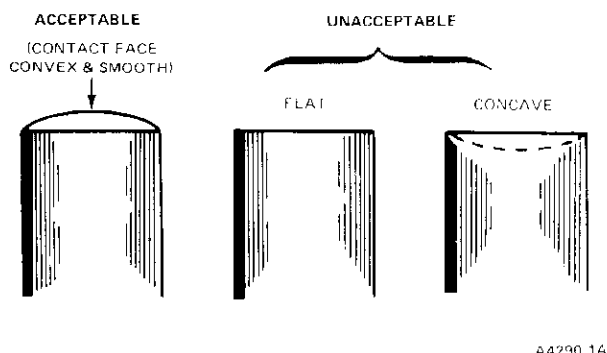
**FIG. 6 Tappet Inspection (Exaggerated Contours Shown)**

7. To check the accuracy of the original indicator reading, continue to rotate the crankshaft until the indicator reads zero. **If the lift on any lobe is below specified service limits, the camshaft and the tappets operating on the worn lobe(s) must be replaced, as well as any tappet that shows pitting or having contact face worn flat or concave.**

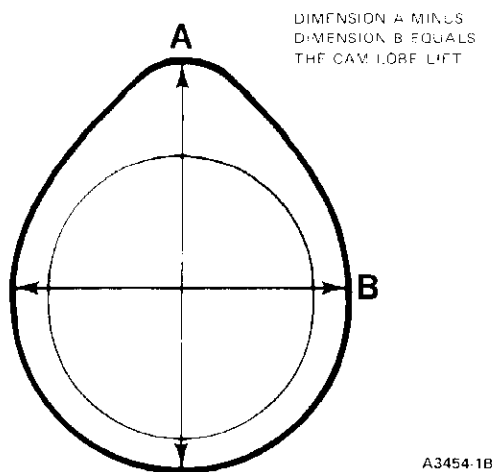
**FIG. 7 Measuring Camshaft Lobe Lift**

1. Remove the air cleaner and the valve rocker arm cover.
2. Measure the distance between the major (A—A) and minor (B—B) diameters (Fig. 7) of each cam lobe with a Vernier caliper and record the readings. The difference in the readings on each cam diameter is the lobe lift.
3. If the readings do not meet specifications, replace the camshaft and all rocker arms.
4. Install the valve rocker arm cover and the air cleaner.

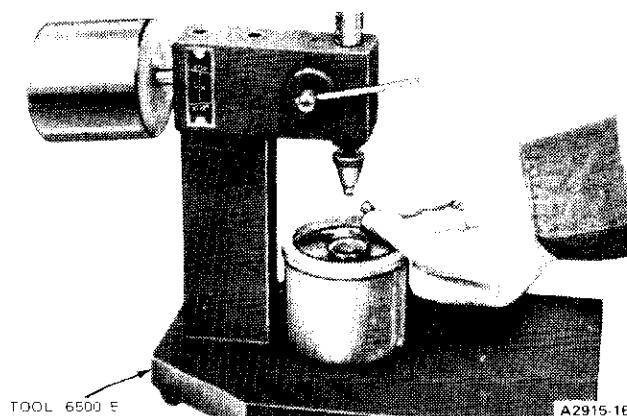
**FIG. 8 Placing Steel Ball in Valve Tappet Plunger**

1. Disassemble and clean the tappet to remove all traces of engine oil. **NOTE:** Do not mix parts from different tappets. Parts are select-fitted and are not interchangeable.
2. Place the tappet in the tester, with the plunger facing upward. Pour hydraulic tester fluid into the cup to a level that will cover the tappet assembly. The fluid can be purchased from the manufacturer of the tester. Using kerosene or any other fluid will not provide an accurate test.
3. Place the 5/16-inch steel ball provided with the tester in the plunger cap (Fig. 8).
4. Adjust the length of the ram (Fig. 9) so that the pointer is 1/16 inch below the starting mark when the ram contacts the tappet plunger, to facilitate timing as the pointer passes the Start Timing mark.

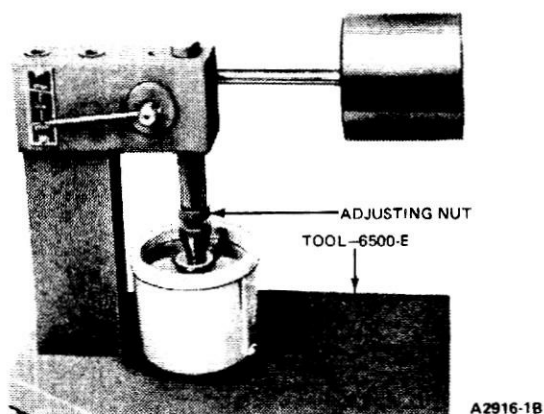
**FIG. 9 Adjusting the Ram Length**

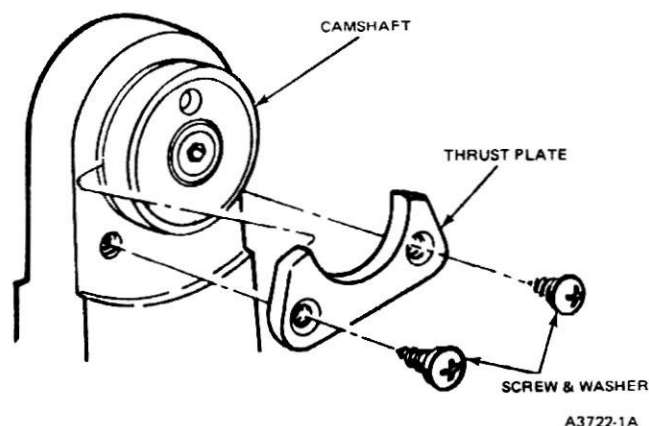
**FIG. 10 Cam Shaft Thrust Plate Installation—2.3L I-4**

Remove the camshaft drive belt cover. Push the camshaft toward the rear of the engine. Install a dial indicator so that the indicator point is on the camshaft sprocket attaching screw or gear hub. Zero the dial indicator. Position a large screwdriver between the camshaft sprocket or gear and the cylinder head. Pull the camshaft forward and release it. Compare the dial indicator reading with specifications. If the end play is excessive, replace the thrust plate at the rear of the cylinder head (Fig. 10). Remove the dial indicator and install the camshaft drive belt cover.

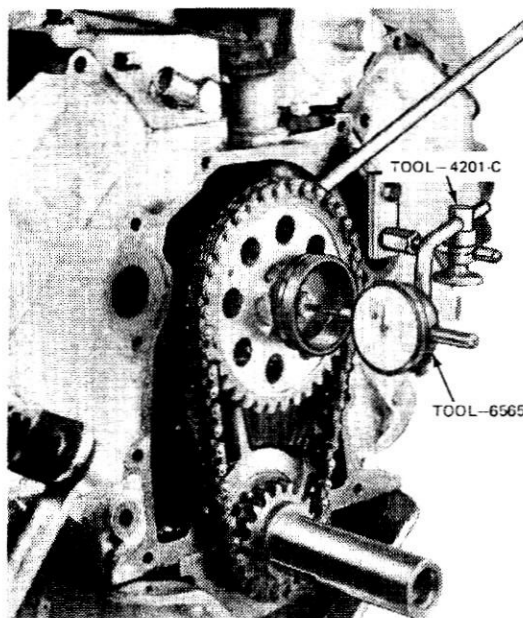
**FIG. 11 Checking Camshaft End Play—Typical V-8 Engine**

Push the camshaft toward the rear of the engine. Install a dial indicator so that the indicator point is on the camshaft sprocket attaching screw (Figs. 11, 12 and 13). Zero the dial indicator. Position a large screwdriver between the camshaft sprocket or gear and the block. Pull the camshaft forward and release it. Compare the dial indicator reading with specifications. If the end play is excessive, replace the thrust plate.
