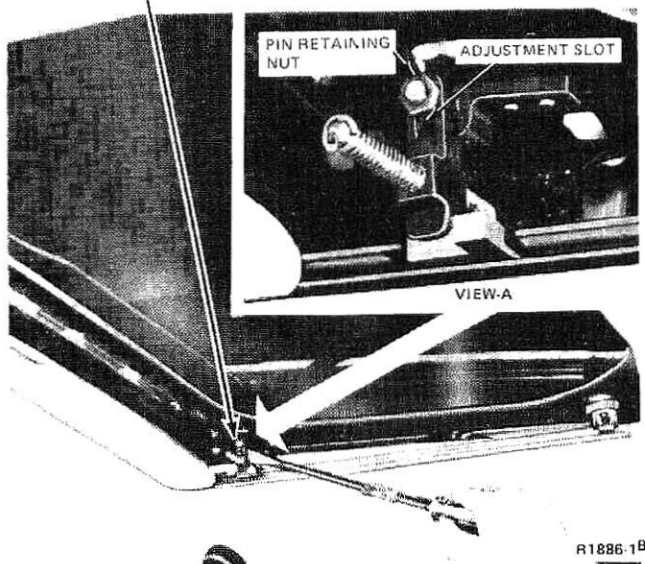
1. LOOSEN PIN RETAINING NUT.
2. POSITION SLIDING PANEL UP OR DOWN AS REQUIRED TO OBTAIN PROPER FLUSHNESS SETTING.
3. TORQUE RETAINING NUT TO 20-23 INCH LBS.

**FIG. 16 Rear Sliding Flushness Adjustment**

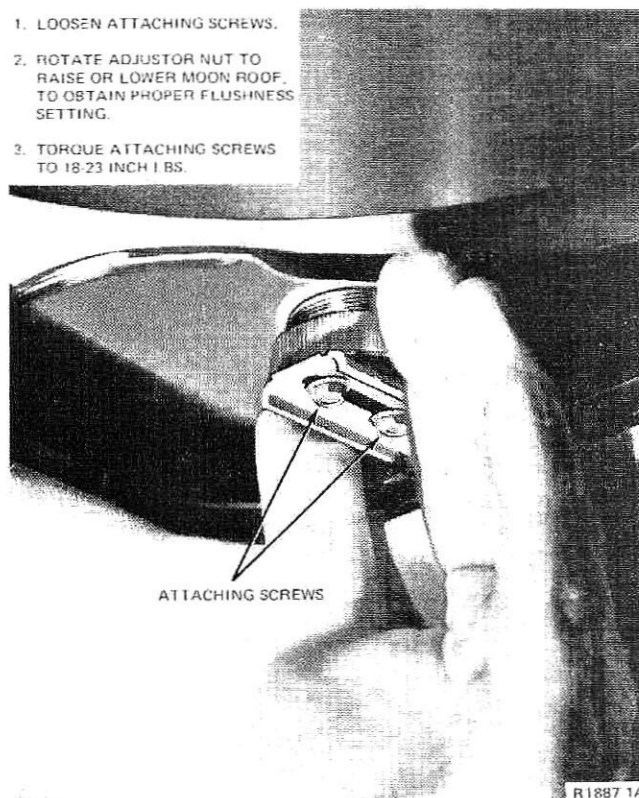
1. LOOSEN ATTACHING SCREWS.
2. ROTATE ADJUSTOR NUT TO RAISE OR LOWER MOON ROOF. TO OBTAIN PROPER FLUSHNESS SETTING.
3. TORQUE ATTACHING SCREWS TO 18-23 INCH LBS.

**FIG. 18 Front Sliding Panel Flushness Adjustment**

2. To raise or lower the forward edge of the sliding panel, loosen the forward track shoe retaining screws. Refer to Fig. 18. Rotate the adjuster (clockwise lowers panel, counterclockwise raises panel) as required to obtain a flush fit to adjacent roof panel. Re-torque the track shoe attaching screws to 18-23 in-lbs.

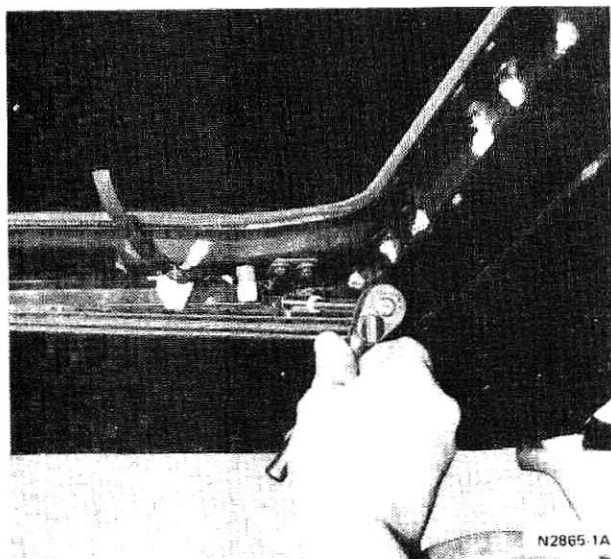
**FIG. 17 Rear Roof Panel Adjustment**

adjusting nut (See Fig. 17), raise or lower the panel to achieve correct alignment, and tighten the adjusting nut (24-36 in-lbs).

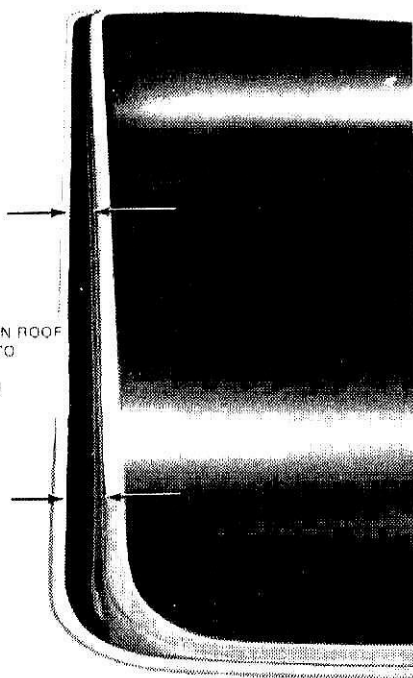
R1882 1A

SIGHT DOWN GAP BETWEEN ROOF PANEL AND MOON ROOF TO DETERMINE IF PANEL IS POSITIONED PARALLEL IN THE OPENING.

**FIG. 19 Sliding Roof Panel Parallel Adjustment**

Sliding panel binding can be caused by unparallel alignment of sliding panel causing the sliding panel to cock in the opening (Fig. 19) or binding of the pivot pins which does not allow the sliding panel to raise at rear corners when cycled to full closed position (Fig. 20).

1. Cycle the roof open about 1/4 inch and sight down the opening to assure that the sliding panel is parallel to the opening. Refer to parallel alignment to correct.
2. The pivot pins, which are attached to the lifter brackets may be too tight in the pivot brackets. This causes the system to function normally through all cycles except the lift cycle. At that point in the cycle, the pivot pins must freely rotate in the pivot bracket. Binding pivot pins can cause the pivot pins to "walk" out of the pivot bracket when the system is cycled numerous times. (Refer to Fig. 19.) If the condition is caused by binding pivot pins, remove the pins from the brackets and ream with a 13/64

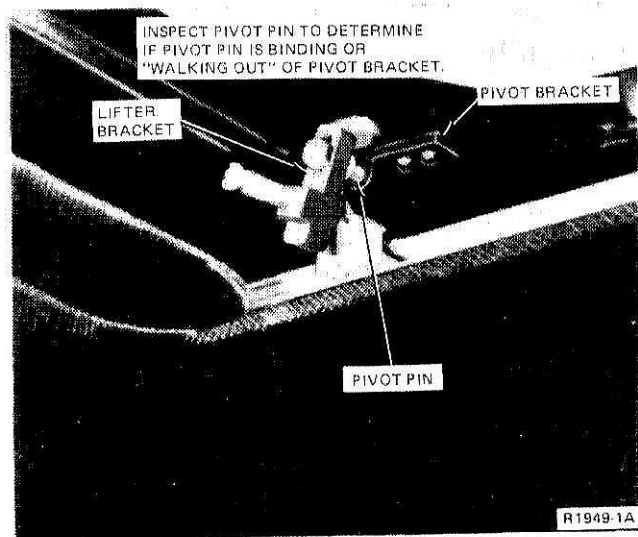
**FIG. 20 Inspection for Binding Pivot Pin**

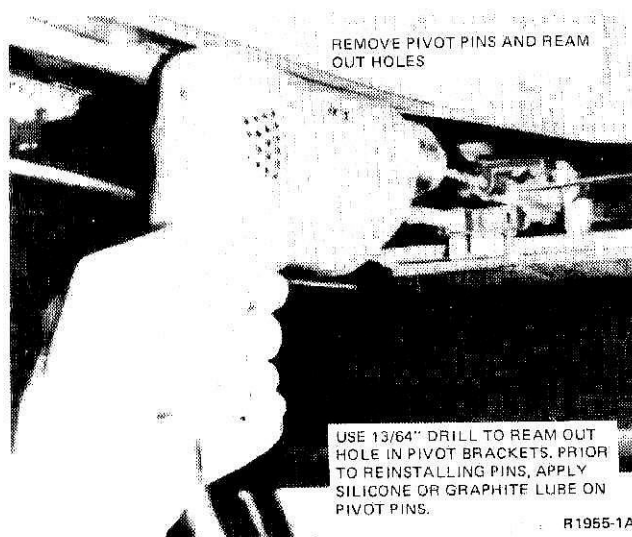
**FIG. 21 Reaming Pivot Bracket for Pivot Pin**

inch drill. Apply silicone lube on the pivot pin and reinstall. Cycle system to assure that the panel is fully raising. Adjust the panel, if required, to obtain a flush fit to the roof panel. (Refer to Fig. 21.)

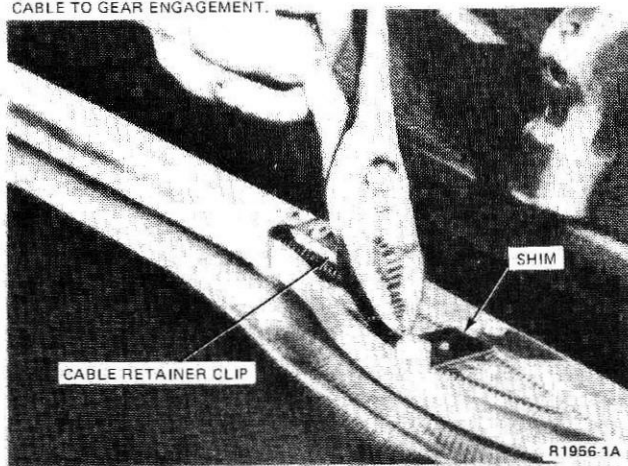
POSITION .030" SHIM STOCK  
BETWEEN RETAINER CLIP AND  
TRACK WALL TO INCREASE  
CABLE TO GEAR ENGAGEMENT.

FIG. 22 Increasing Cable-To-Gear Engagement

and position the retainer clip. Install a .030" shim between the track wall and retainer clip to provide additional gear to cable engagement on the side that exhibits clearance. Refer to Fig. 22.

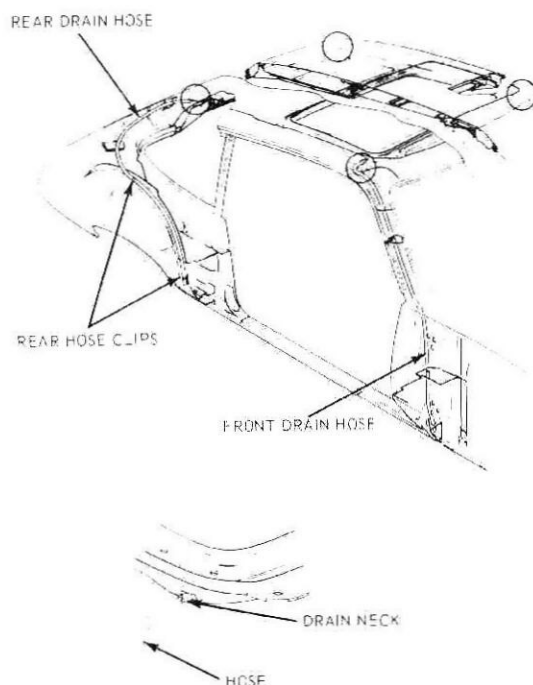
R1551-1A

FIG. 23 Water Drainage System

The roof panel module contains the track assemblies, cable and drive mechanisms, and a drain trough that encircles the sliding panel. Attached to the module are four (4) drain hoses. One drain hose is attached at each corner of the module. The two front drain hoses are routed down the windshield pillars and into the cowl sides exiting at rocker panel drain darts—ends of hose are **not** reusable. The two rear drain hoses are routed down the rear pillars over the rear wheel house and into the rear quarters. Refer to Fig. 23.
